Rochester Vermont

Town Building Audit

October 5, 2021

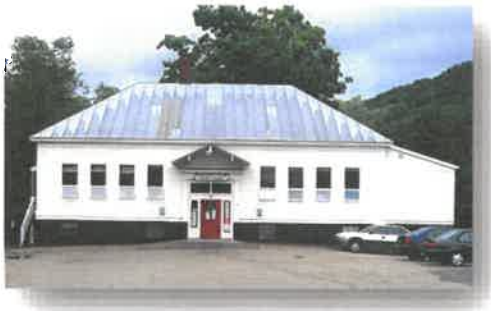
The town hall building is an old build that has been added on to on several occasions. The building is heated by a 30 plus year old single zone oil hot air furnace located in the basement. The air passes through ductwork routed through the building to the local zones. No measurable outside air was noticed in the existing furnace system. While reviewing the building with town staff many issues were discussed such as equipment age, serviceability, zone comfort and efficiency.

- Town meeting space is not large enough for large crowd accommodation. Meetings frequently are held in other locations to accommodate larger crowds.
- Existing town vault is not large enough for records and record expansion.
- The records vault is cold in the winter and does not have humidity control. The vault essentially sits outside the building envelope and has no heating inside the space. The open door to the clerk's office is to only means of heat.
- Building heating system is old. The 1980s era oil furnace has single zone control and has lower efficiencies than systems available today.

Replacing the oil-fired heating system with a significantly more efficient heat pump system will provide better zone comfort and provide energy savings. The heat pump system provides heating and cooling needs and more independently controlled zones.

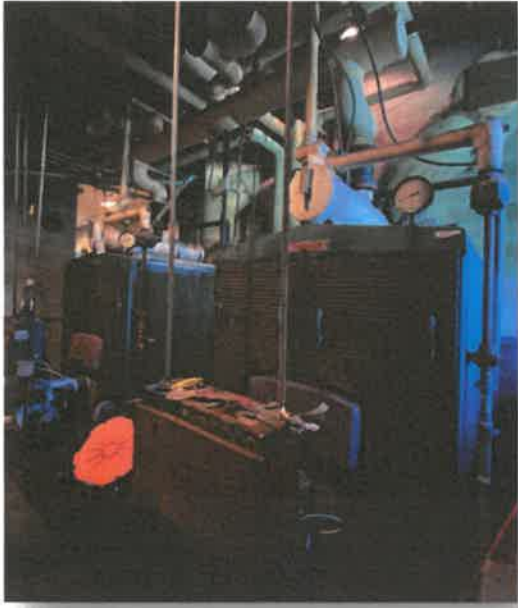
The existing boilers are lower efficiency oil fired boilers that are beyond the industry standard of life (25yrs) and should be replaced with energy compliant boilers such as condensing boilers. The piping system has not been as active and there are concerns about pipe integrity. Localized rusting of the piping will have occurred and the system should be tested to see if extensive work on the piping system is needed or piping replaced. The budgetary cost to address the piping alone could be approximately \$250,00 to \$500,000 for testing, demolition, pipe upgrades, insulation, flushing and water treatment depending on the depth of work required.

Oil fired boilers at High School.

The existing pumps and hydronic appurtenances are old and should be removed and replaced with new more efficient equipment. New pumps with VFD's (Variable Frequency Drives), air separators, expansion tanks, gauges, and isolation valves should be part of the new boiler system upgrade.

New condensing boilers should be installed to replace the existing boiler system. The existing oil tank and piping system should be removed and new LP gas tanks installed.

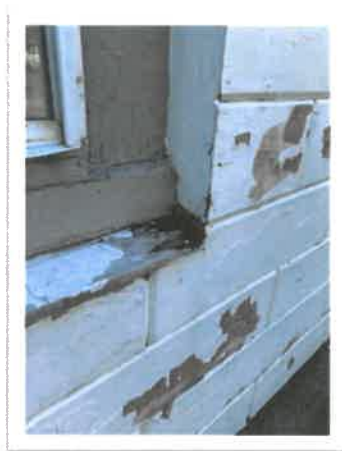
The building envelope has issues with water damage and decay. There are several areas around windows where the sill has completely rotted out and water is infiltrating into the structure of the building. A continued cycle of water infiltration will rot out the supporting structure and cause mold and mildew issues. Air is also infiltrating the walls in these areas and causing energy loss and additional condensation in the winter time. The exterior paint is now flaking off the siding which leads to the wood to be exposed and additional water penetration into the wall structure. The existing paint is likely to have lead in it and should be tested. Appropriate steps should be taken ASAP to handle the work.

Library window sill and siding on north side.

The exterior walls should be addressed and made weather tight. The decayed wood sills around windows and base boards should be removed and the inside structure should be inspected for damage. If no significant damaged is found it should be treated. The siding and window trim should be replaced and made water tight. The exterior siding of the entire building should be cleaned and prepped for painting and sealing of all joints to protect the building.
